CORPS OF ENGINEERS BALTIMORE MD BALTIMORE DISTRICT  
NATIONAL DAM INSPECTION PROGRAM. ICE POND DAM (NDI ID NUMBER PA--ETC(U)  
APR 81

# ICE POND DAM

NDI ID NO. PA-00566  
DER ID NO. 40-79

## PHASE I INSPECTION REPORT NATIONAL DAM INSPECTION PROGRAM

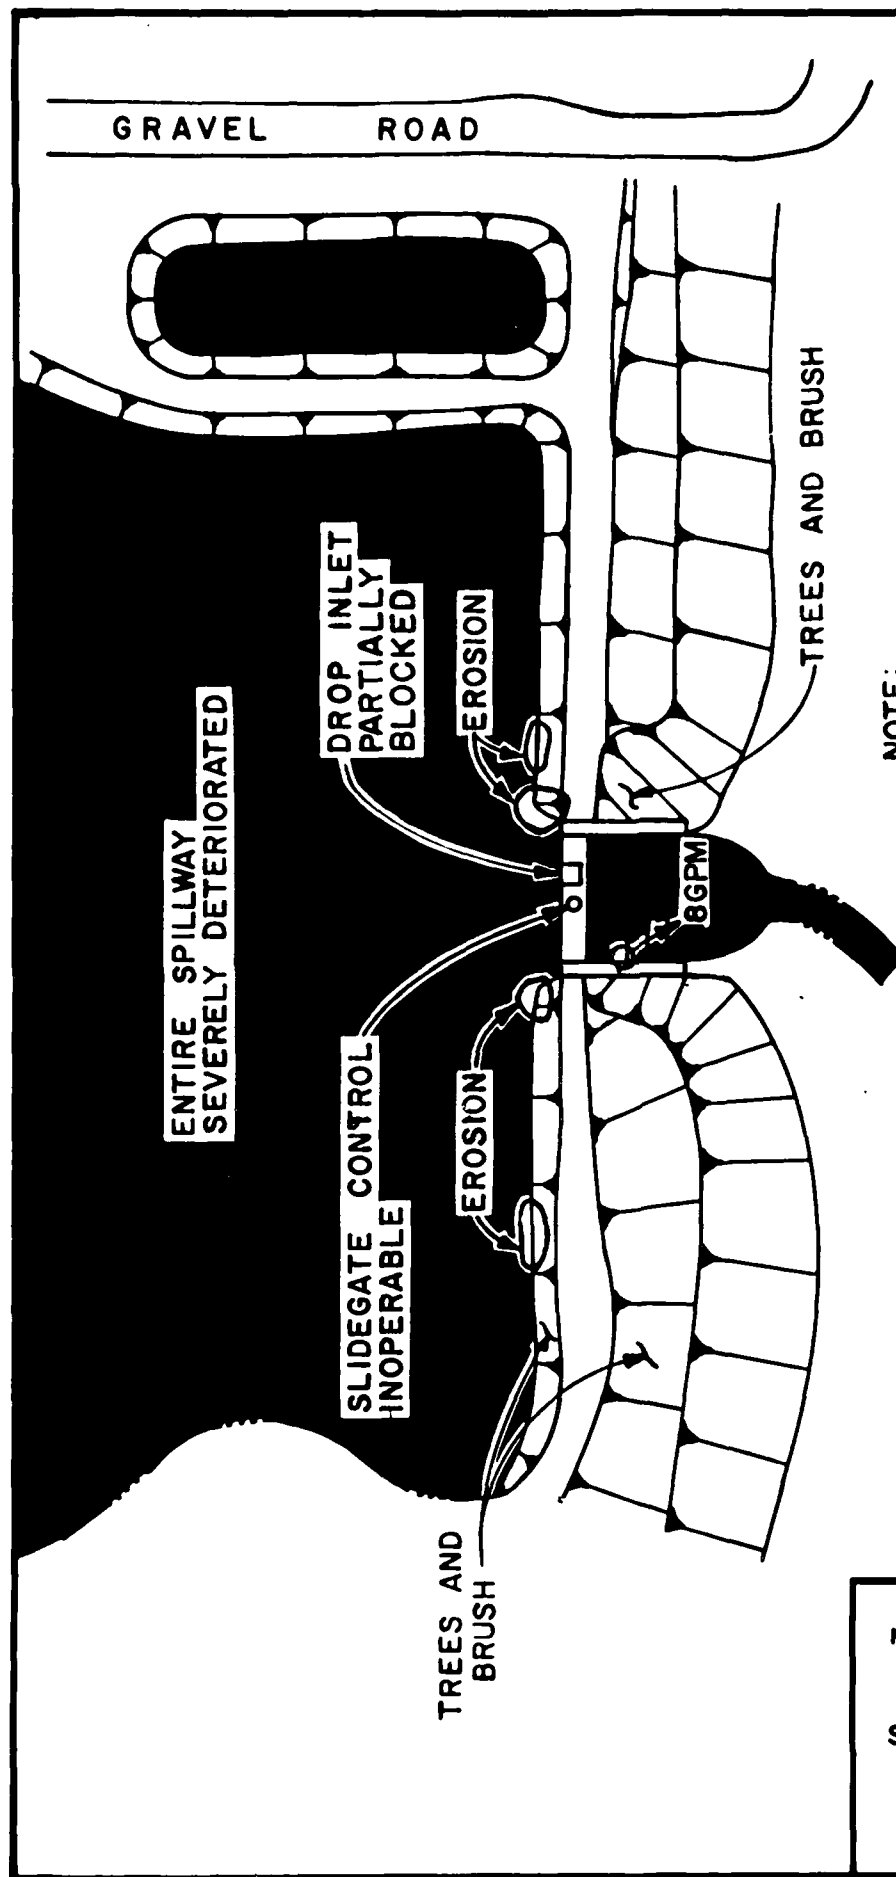
EXHIBIT A-1

NOTE:  
SPILLWAY HAS MAKESHIFT  
BRIDGE - NEAR COLLAPSE

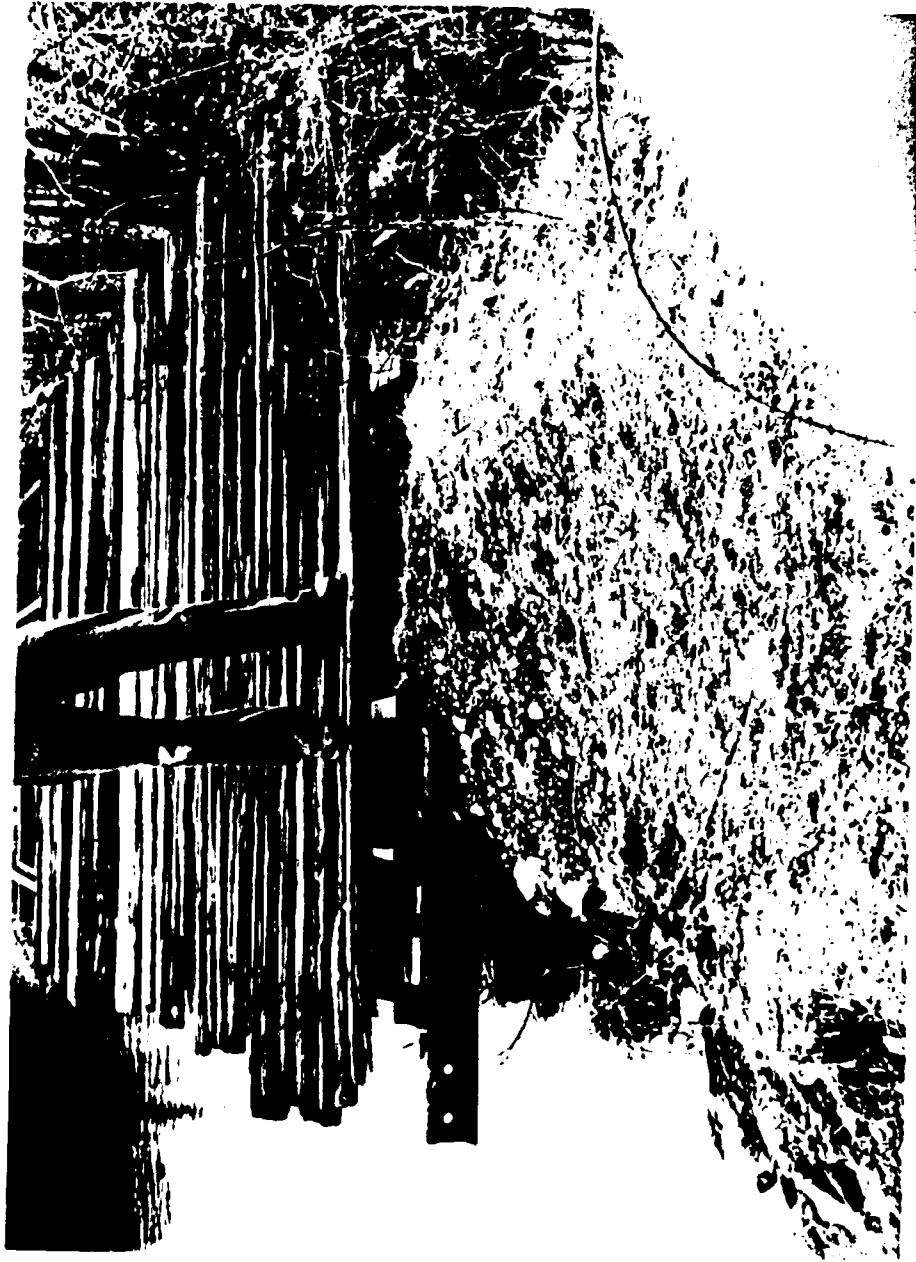
b. Embankment. The horizontal alignment of the crest is good with no evidence of cracking or instability. The upstream face slopes at 1V:2.5H except for the upper two feet which varies in slope from 1V:1H to near vertical. The massive downstream face is irregular with the slopes varying between 1V:5H and 1V:12H for at least 40 feet downstream before steepening to 1V:2H. This irregularity is apparently due to the random placement of large quantities of additional fill sometime after construction and not from any stability problems. Two to twelve inch stone protects the entire upstream face below the spillway crest elevation. The slope above this elevation is steep, apparently due to erosion. Localized erosion has reduced the crest width to 3.5 feet near the spillway. The upstream face near the crest is covered with brush and some trees. The portion of the crest to the right of the spillway and the entire downstream face of the dam are overgrown with brush and trees. The vertical alignment varies a maximum of about one foot with the low spot occurring approximately 120 feet to the left of the spillway. No signs of seepage, sloughing or instability were observed.

3. Erosion of crest adjacent to right spillway wall.

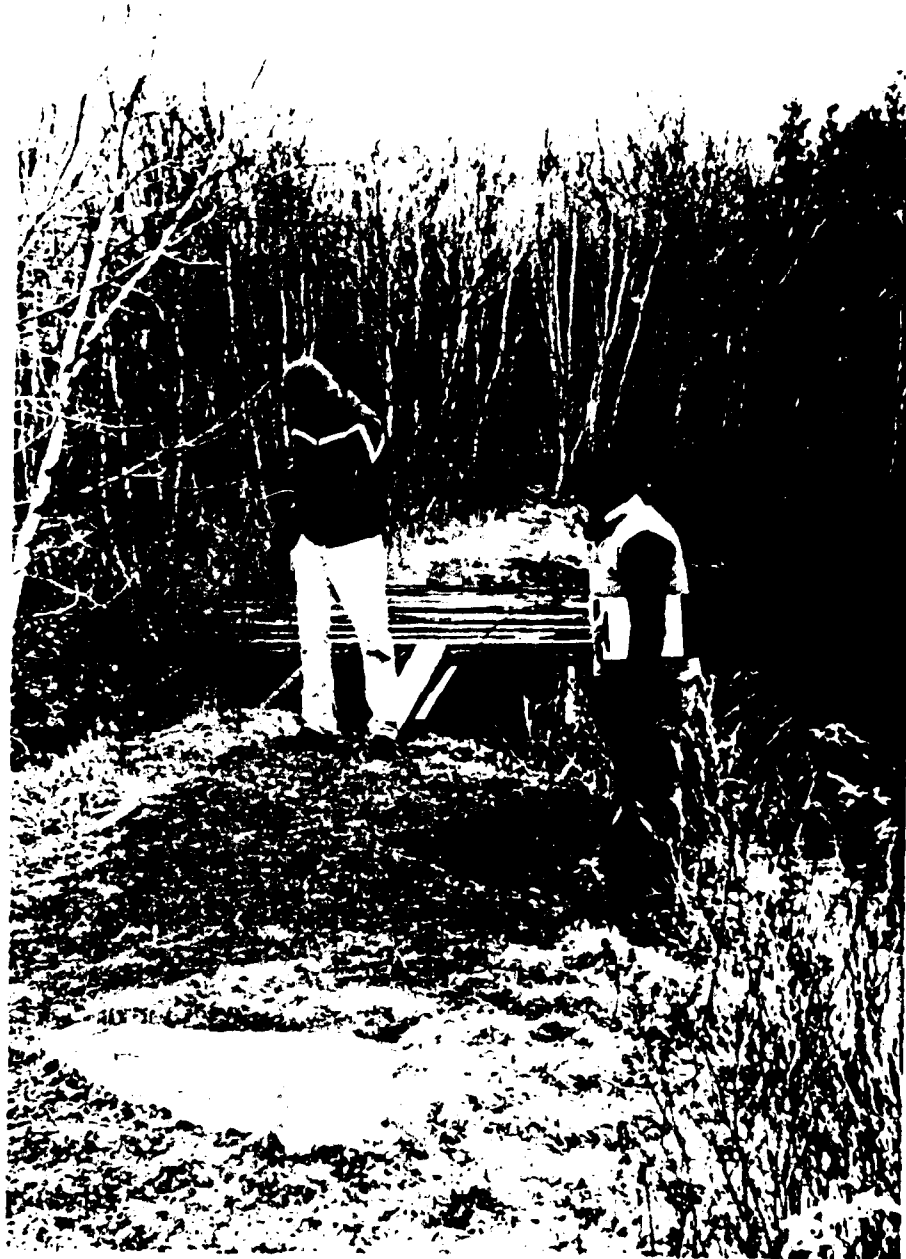
VISUAL EXAMINATION OF	OBSERVATIONS
Sloughing or Erosion: Embankment Crest/Slope Abutment Slopes	Upper two feet of upstream face eroded to near vertical; severe local erosion at crest. No erosion of abutment slopes
Riprap	2"-12" stone with average size of 6". On upstream face below spillway crest elevation only. No failures.
Staff Gage and Recorder	None
Instrumentation	None
Miscellaneous	Brush along upstream slope; heavy brush and trees along right half of crest and along entire downstream face.

4. Erosion of upstream face and crest.  
Spillway bridge in background.

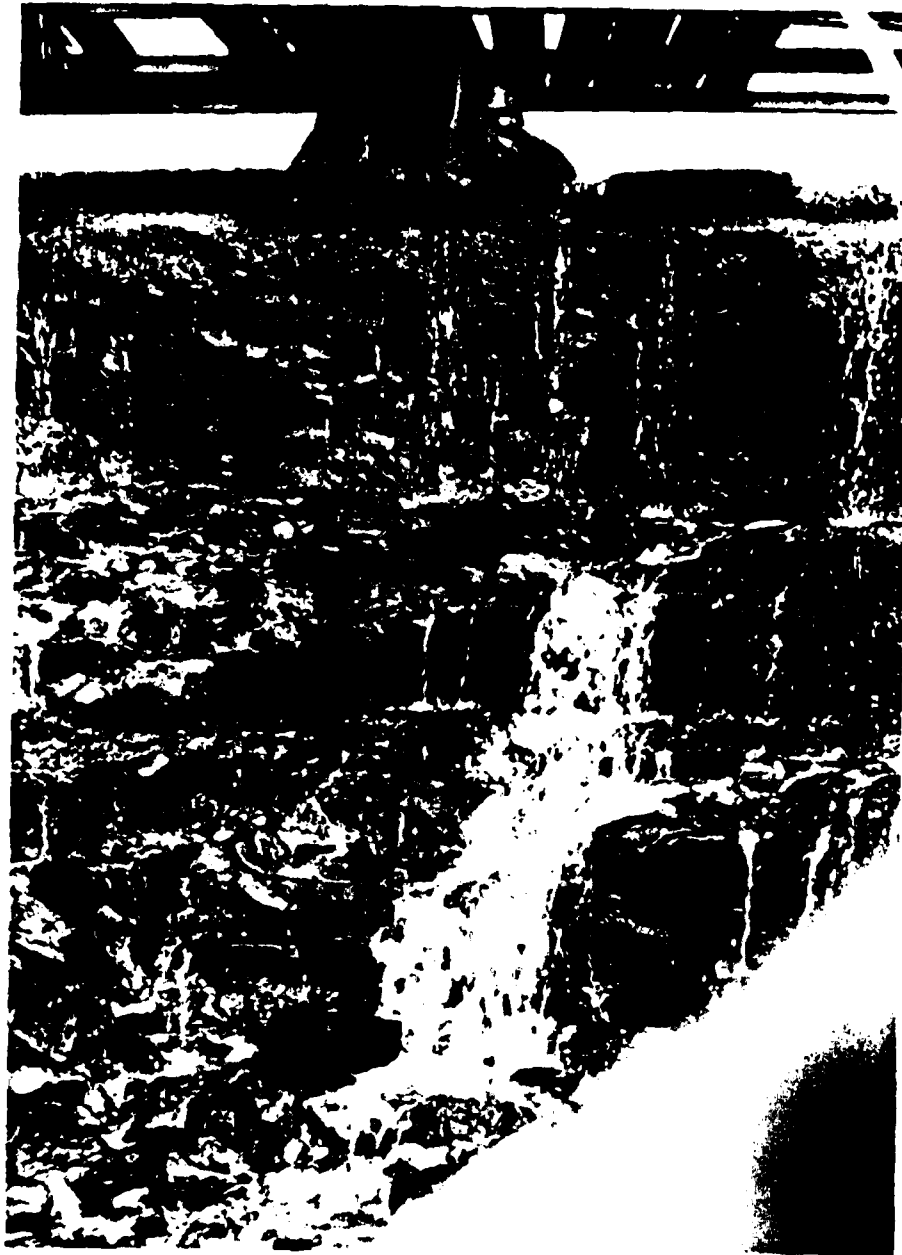
9. Center portion of downstream face  
of spillway. Note deteriorated bridge  
pier at top of picture.
